# H-M of a Long Span Bridge

Case Study<sup>1</sup>

# Field Studies at CBB

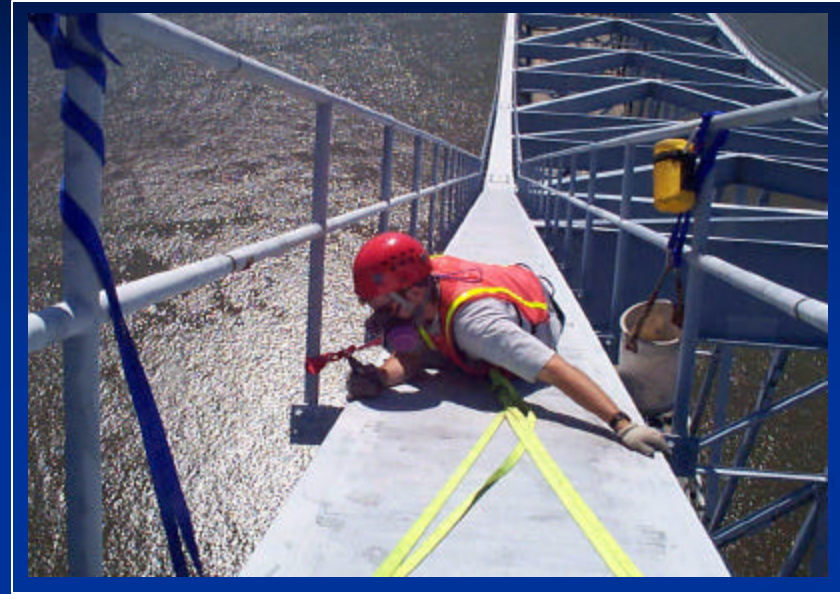
**Sensor Installation at Tower**

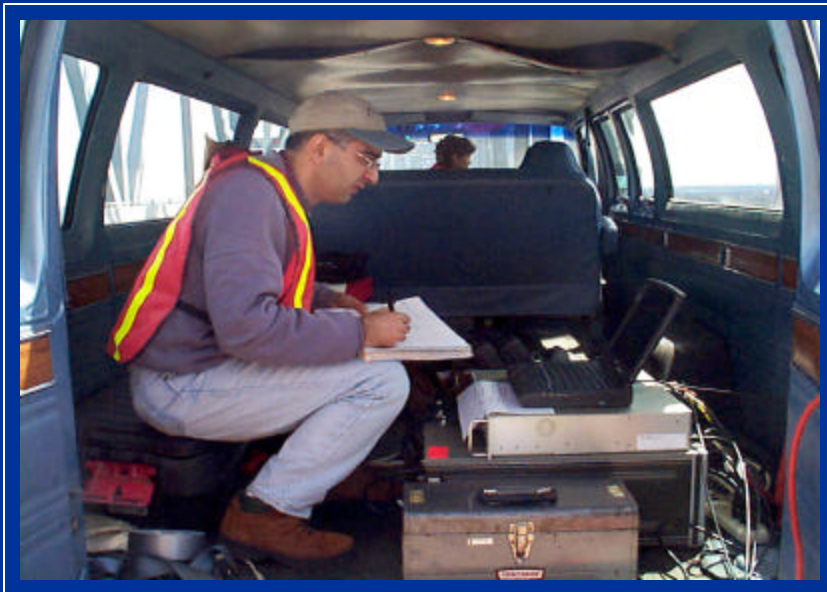
**Data Acq. During Damper Testing**

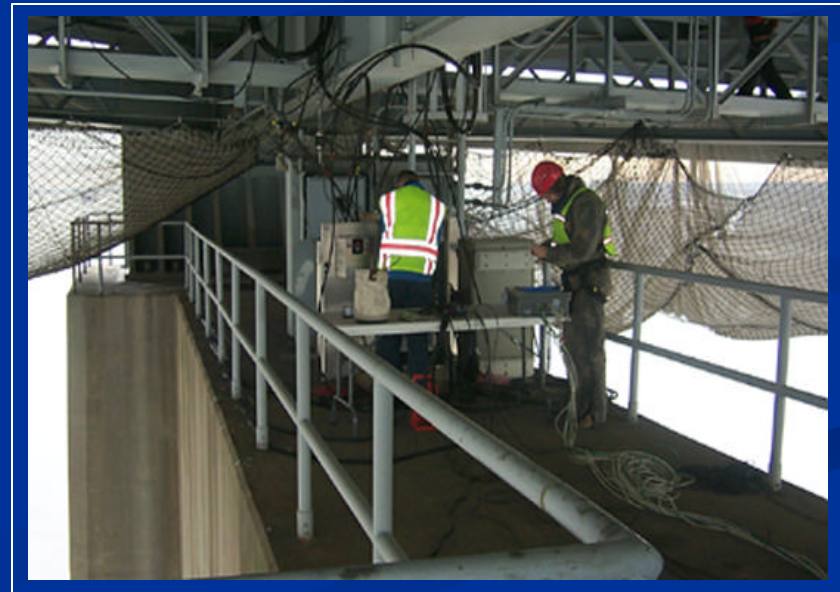
**Preparation of the Pier Cabinet for DAQ**

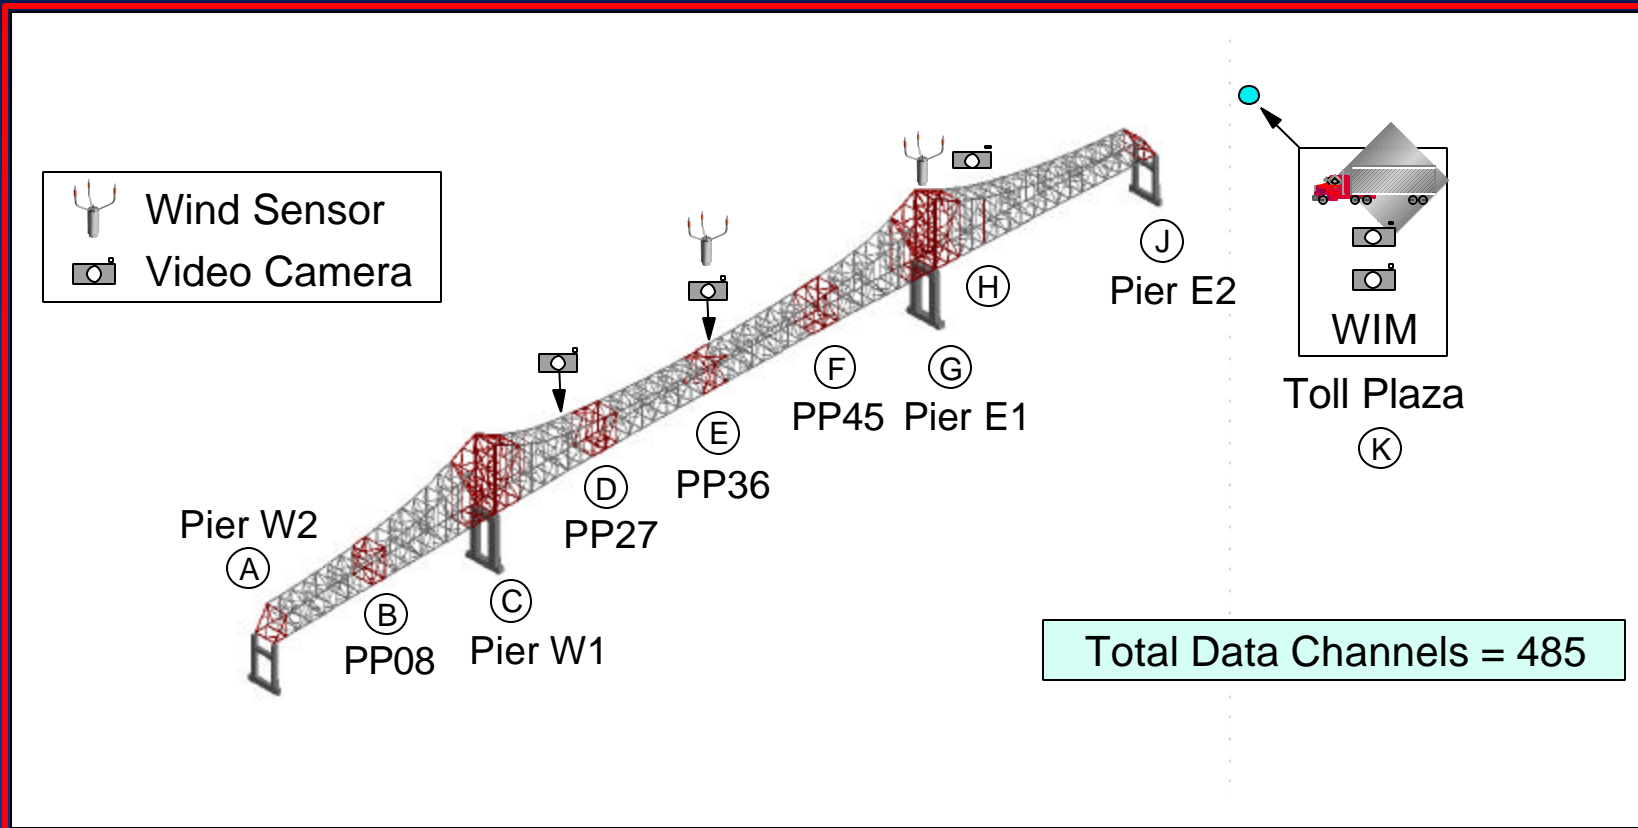
# CBB Instrumentation Map for the Phenomena to be Measured

PHENOMENA	MEASURAND	SENSOR	QTY	LOCATIONS
Traffic	Image	Video Camera	4	D, E, J
	Speed & Weight	WIM System	2 Lanes	K
Weather	Air Temperature Relative Humidity Solar Radiation	Weather Station	1	G
	Wind Speed & Dir.	Ultrasonic Wind	4	E, G
Bridge Responses	Live Load Strains	Q.B. Strain Gage	56	C, D, E, F
	Environ. Strains	V.W. Strain Gage	148	A, C, D, E, F, J
	Temperature	Thermistor	201	A, C, D, E, F, G, J
	Displacements	V.W. Crackmeter	17	A, D, F, J
	Tilts	V.W. Tiltmeter	36	A, C, D, F, G, J
	Accelerations	Cap. Accelerometer	16	B, D, F, H

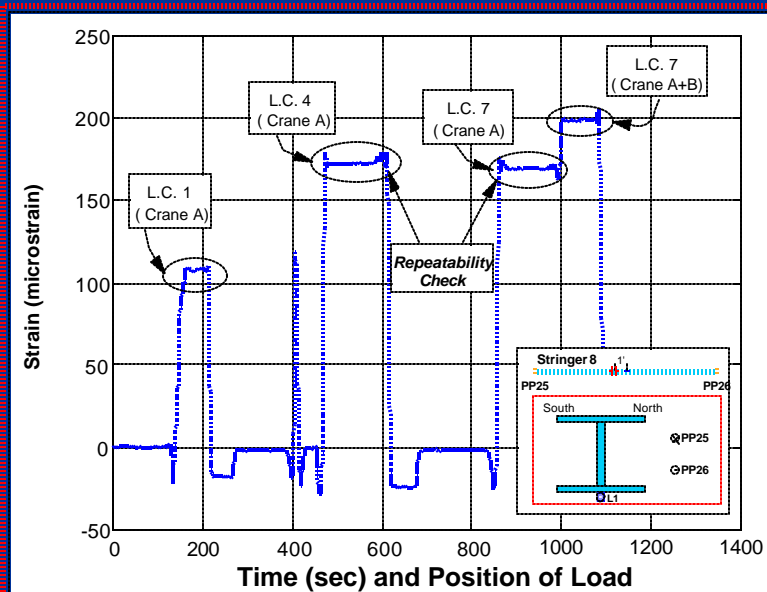
Crawl Speed Test Data for Influence Line Generation
